FACILITY CONDITION ASSESSMENT

FOOTHILL-DE ANZA COMMUNITY COLLEGE DISTRICT
FHDA Facility Condition Assessment
FOOTHILL COLLEGE
1900 ADMINISTRATION

Report for Project Planning

September 27, 2021

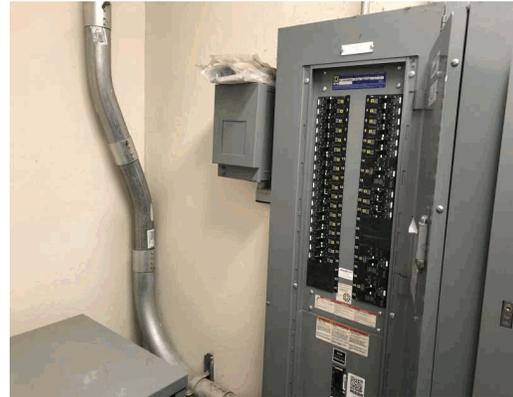
Item #: 794199
Uniformat Number: D5020
Item Title: Arc Flash Hazard Analysis and Short Circuit Coordination
Caption: No arc flash hazard stickers
Priority: 1 - Currently Critical

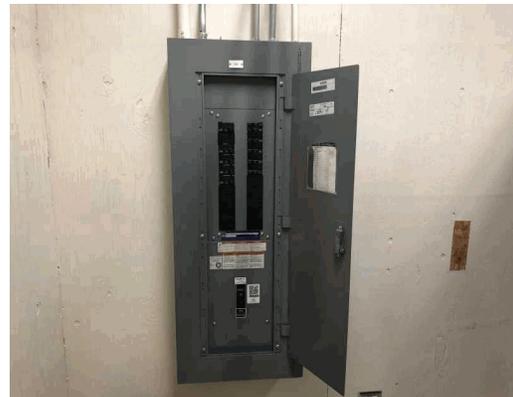
Item #: 794199
Uniformat Number: D5020
Item Title: Arc Flash Hazard Analysis and Short Circuit Coordination
Caption: No arc flash hazard stickers
Priority: 1 - Currently Critical

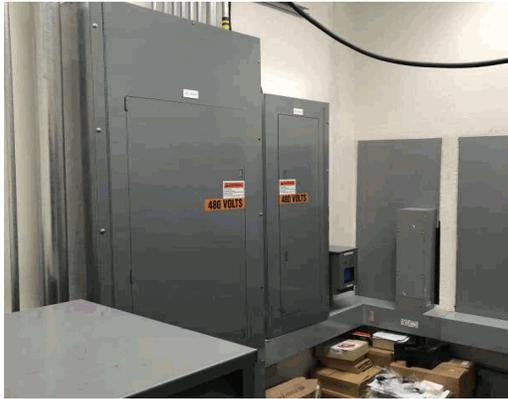
Item #: 794199
Uniformat Number: D5020
Item Title: Arc Flash Hazard Analysis and Short Circuit Coordination
Caption: Generic arc flash hazard stickers
Priority: 1 - Currently Critical

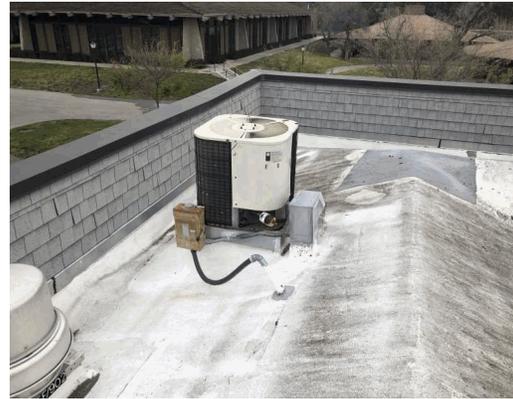
Item #: 794207
Uniformat Number: D5080
Item Title: Miscellaneous Electrical Systems (Mech Connections)
Caption: Weathered components
Priority: 1 - Currently Critical

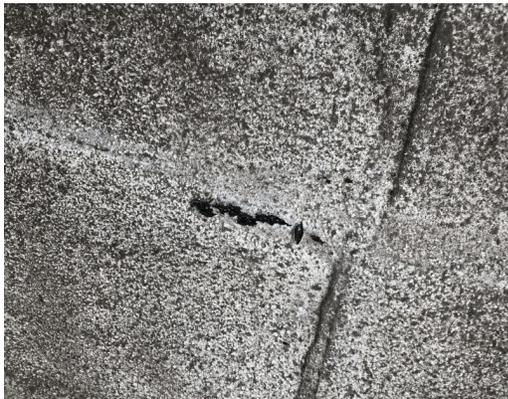
Item #: 793508
Uniformat Number: B3010
Item Title: Roofing Membrane
Caption: Roofing Membrane - Deteriorated
Priority: 2 - Potentially Critical

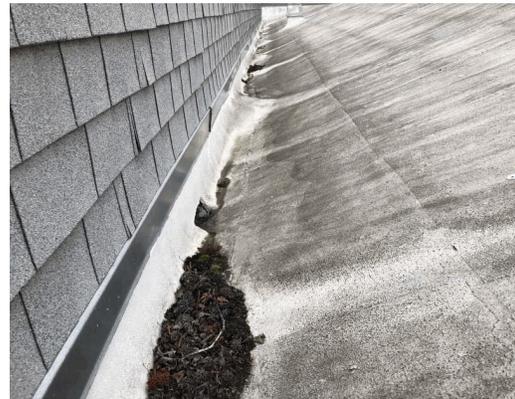
Item #: 793508
Uniformat Number: B3010
Item Title: Roofing Membrane
Caption: Roofing Membrane - Debris Collecting Vallies
Priority: 2 - Potentially Critical

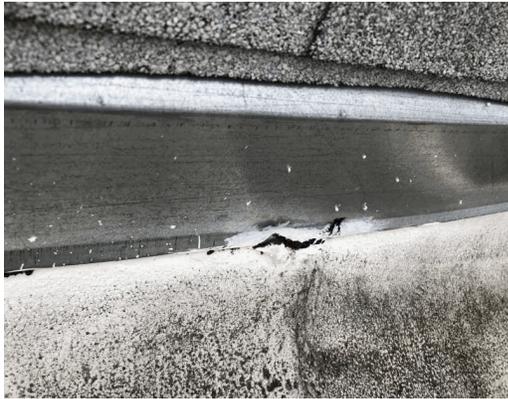
Item #: 793508
Uniformat Number: B3010
Item Title: Roofing Membrane
Caption: Roofing Membrane - Flashing Coating Deteriorated
Priority: 2 - Potentially Critical

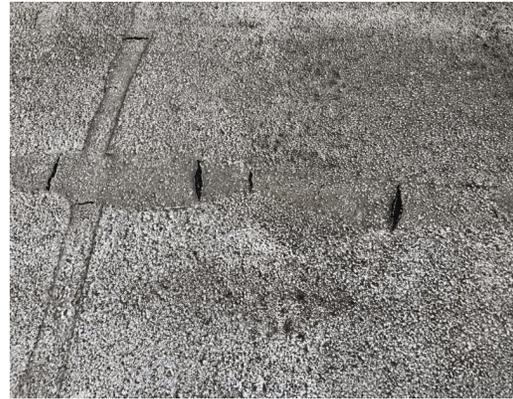
Item #: 793508
Uniformat Number: B3010
Item Title: Roofing Membrane
Caption: Roofing Membrane - Deteriorated
Priority: 2 - Potentially Critical

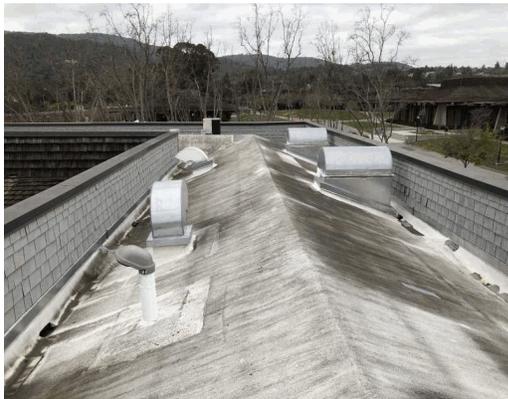
Item #: 793508
Uniformat Number: B3010
Item Title: Roofing Membrane
Caption: Roofing Membrane - Overview
Priority: 2 - Potentially Critical

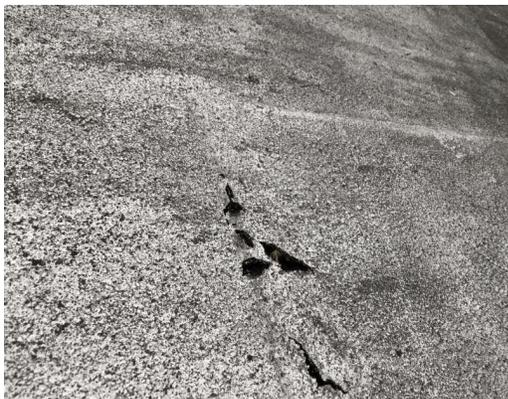
Item #: 793508
Uniformat Number: B3010
Item Title: Roofing Membrane
Caption: Roofing Membrane - Deteriorated
Priority: 2 - Potentially Critical

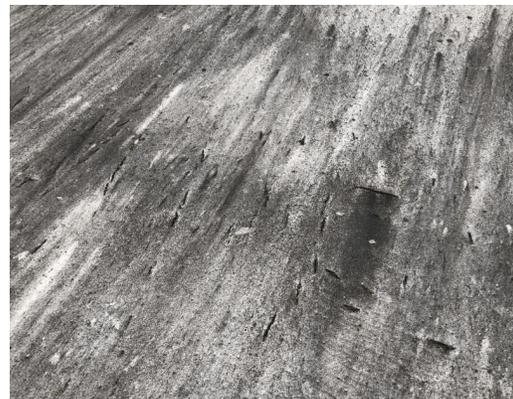
Item #: 793508
Uniformat Number: B3010
Item Title: Roofing Membrane
Caption: Roofing Membrane - Deteriorated
Priority: 2 - Potentially Critical

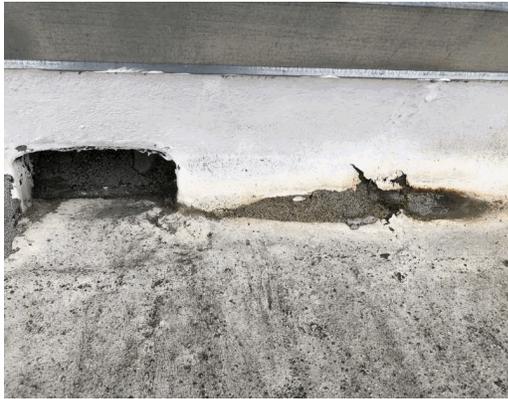
Item #: 793508
Uniformat Number: B3010
Item Title: Roofing Membrane
Caption: Roofing Membrane - Membrane Hole
Priority: 2 - Potentially Critical

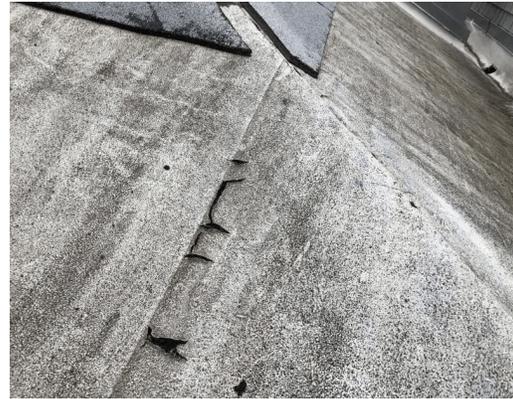
Item #: 793508
Uniformat Number: B3010
Item Title: Roofing Membrane
Caption: Roofing Membrane - Membrane Cracked
Priority: 2 - Potentially Critical

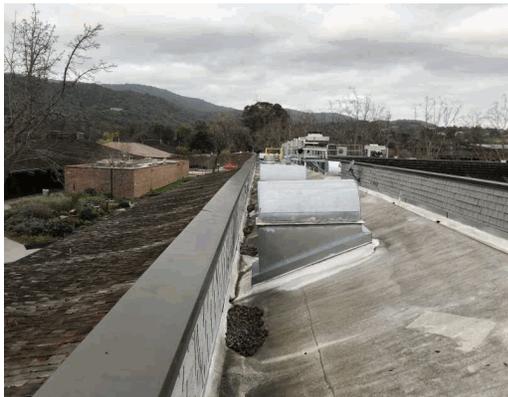
Item #: 793508
Uniformat Number: B3010
Item Title: Roofing Membrane
Caption: Roofing Membrane - Debris Collecting Vallies
Priority: 2 - Potentially Critical

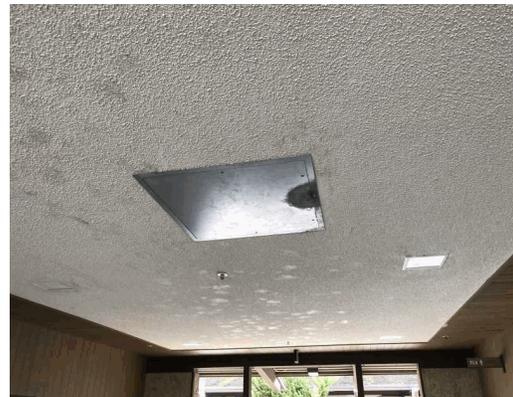
Item #: 793583
Uniformat Number: B2010
Item Title: Exterior Coatings
Caption: Exterior Coatings - Breezeway ceiling
Priority: 4 - Recommended

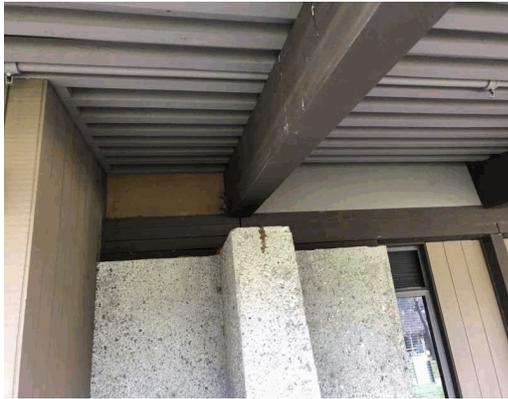
Item #: 793583
Uniformat Number: B2010
Item Title: Exterior Coatings
Caption: Exterior Coatings - Wood structure and siding
Priority: 4 - Recommended

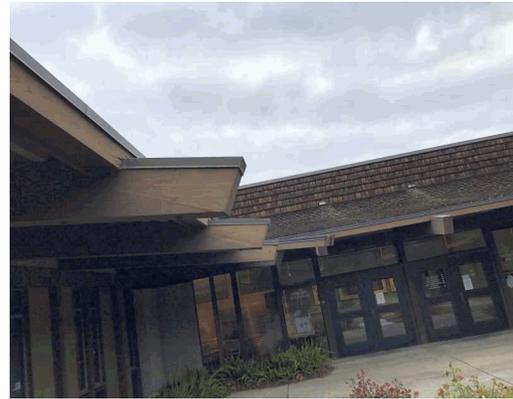
Item #: 793583
Uniformat Number: B2010
Item Title: Exterior Coatings
Caption: Exterior Coatings - Rafter Tails
Priority: 4 - Recommended

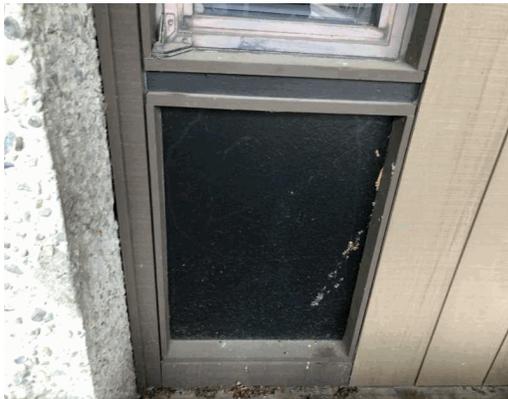
Item #: 793583
Uniformat Number: B2010
Item Title: Exterior Coatings
Caption: Exterior Coatings - Windows panels
Priority: 4 - Recommended

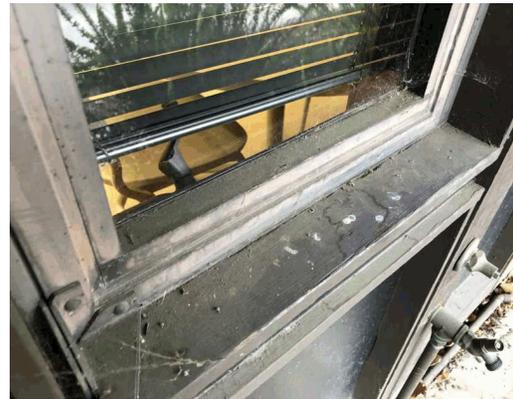
Item #: 793583
Uniformat Number: B2010
Item Title: Exterior Coatings
Caption: Exterior Coating - Window Sills
Priority: 4 - Recommended

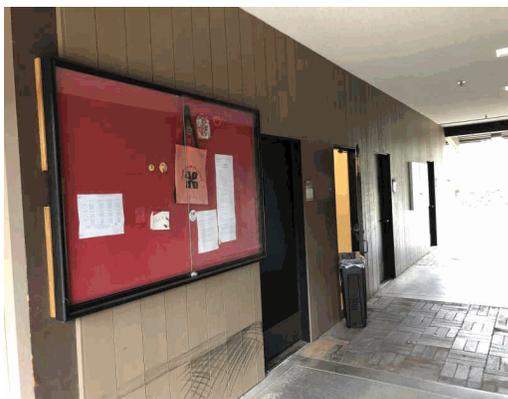
Item #: 793583
Uniformat Number: B2010
Item Title: Exterior Coatings
Caption: Exterior Coatings - Breezeway Walls
Priority: 4 - Recommended

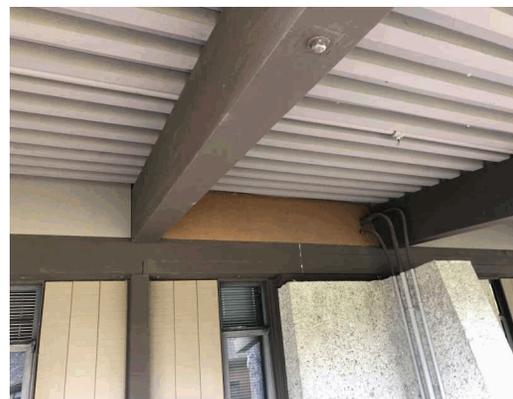
Item #: 793583
Uniformat Number: B2010
Item Title: Exterior Coatings
Caption: Exterior Coatings - Wood structure and siding
Priority: 4 - Recommended

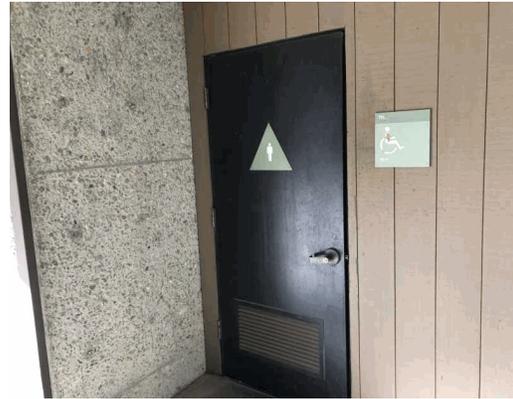
Item #: 793583
Uniformat Number: B2010
Item Title: Exterior Coatings
Caption: Exterior Coatings - Restroom door
Priority: 4 - Recommended

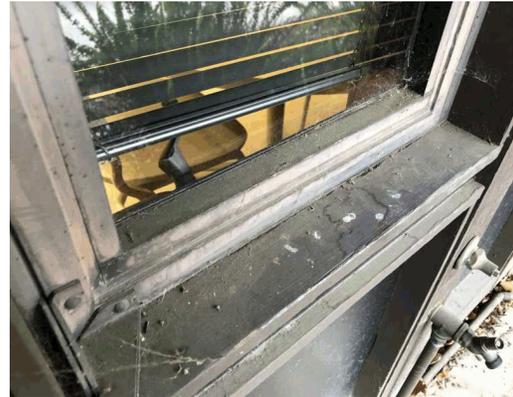
Item #: 793524
Uniformat Number: B2020
Item Title: Exterior Windows
Caption: Exterior Windows - Typical
Priority: 4 - Recommended

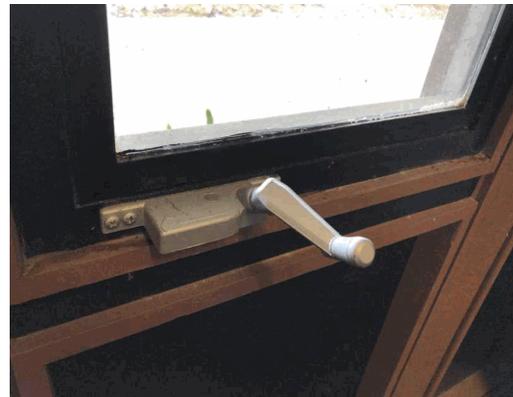
Item #: 793524
Uniformat Number: B2020
Item Title: Exterior Windows
Caption: Exterior Windows - Casement Crank
Priority: 4 - Recommended

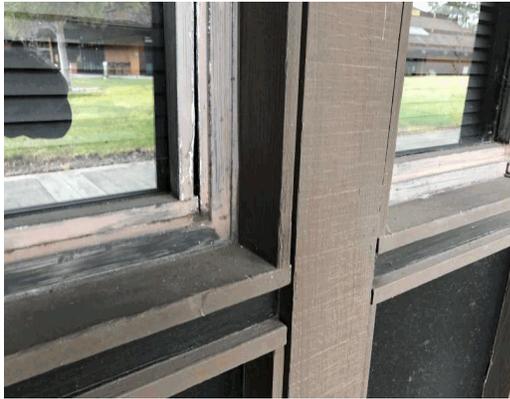
Item #: 793524
Uniformat Number: B2020
Item Title: Exterior Windows
Caption: Damaged frame - East elevation
Priority: 4 - Recommended

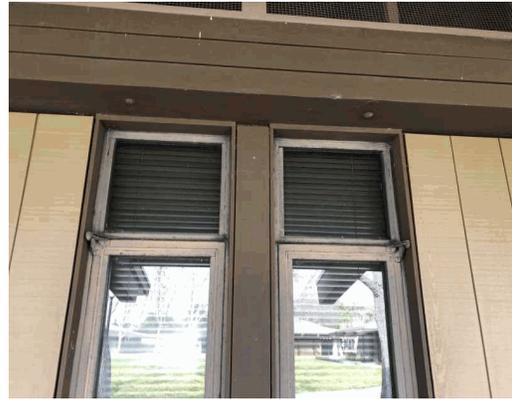
Item #: 793524
Uniformat Number: B2020
Item Title: Exterior Windows
Caption: Deteriorated frames - North elevation
Priority: 4 - Recommended

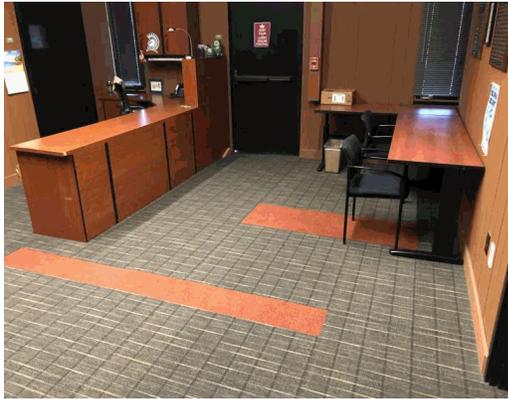
Item #: 793665
Uniformat Number: E2010
Item Title: Fixed Furnishings
Caption: Fixed Furnishings - Countertop
De-laminating
Priority: 4 - Recommended

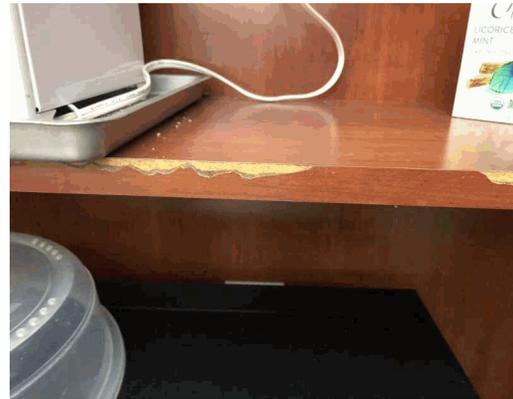
Item #: 793665
Uniformat Number: E2010
Item Title: Fixed Furnishings
Caption: Fixed Furnishings - Shelf De-laminating
Priority: 4 - Recommended
