FACILITY CONDITION ASSESSMENT

FOOTHILL-DE ANZA COMMUNITY COLLEGE DISTRICT
FHDA Facility Condition Assessment
FOOTHILL COLLEGE
1900 ADMINISTRATION

Report for Project Planning

September 27, 2021

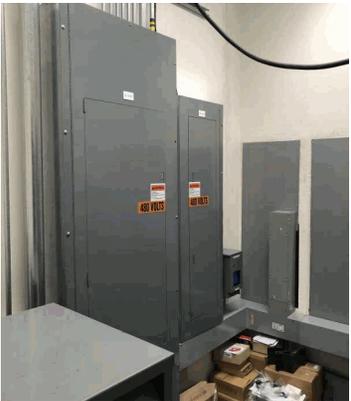
<p> FOScore #: 794199 Uniformat Name: D5020 - Arc Flash Hazard Analysis and Short Circuit Coordination Category: Life Safety - Life Safety Location: Partial Building Area Served: Partial Building Observed Remaining Life: 0 year(s) Act By: 2021 Action Timeframe: 0 year(s) Reference Life (BOMA): 30 year(s) </p>
	<p> Description: Electrical arc flash hazard analysis and short circuit coordination Critical Issues: No evidence of a short circuit coordination study or arc flash hazard assessment. Electrical equipment was not observed as having the required safety information posted. Recommendations: Perform a short circuit coordination study and an arc flash hazard analysis. Make the required changes to the electrical system to ensure proper circuit coordination and to minimize electrical flash hazards. Once completed, appropriate PPE should be purchased for qualified personnel. All electrical equipment must be labeled with the necessary safety information specific to each piece of equipment. (Price reflects the cost of engineering for short circuit coordination and arc flash assessment only.) Repair Factor: 100% </p> <p style="text-align: right;">Pricing Unit: 22,851 BGSF Cost: \$12,699</p>

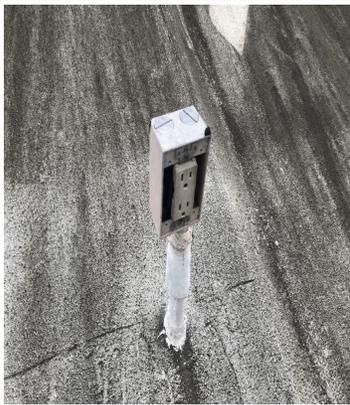
FOScore #: 794207
Uniformat Name: D5080 - Miscellaneous Electrical Systems (Mech Connections)
Category: Building Integrity - Beyond Rated Life
Location: Roof
Area Served: Partial Building
Observed Remaining Life: 3 year(s)
Act By: 2022
Action Timeframe: 1 year(s)
Reference Life (BOMA): 20 year(s)

Description: Electrical wiring and components that support mechanical systems.

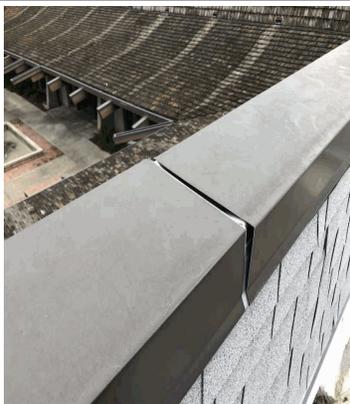
FOScore #: 796334
Uniformat Name: B2080 - Exterior Metal Fabrications
Category: Building Integrity - Reliability
Location: Roof
Area Served: Parapets
Observed Remaining Life: 2 year(s)
Act By: 2023
Action Timeframe: 2 year(s)
Reference Life (BOMA): 75 year(s)

Description: Aluminum copings

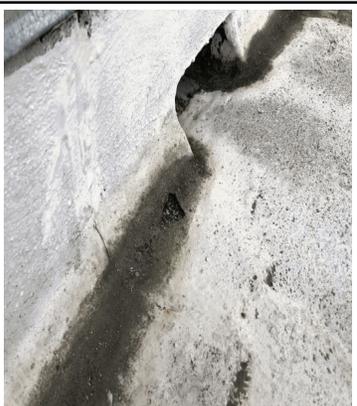
<p> FOScore #: 793508 Uniformat Name: B3010 - Roofing Membrane Category: Building Integrity - Reliability Location: Roof Area Served: Entire Building Observed Remaining Life: 12 year(s) Act By: 2023 Action Timeframe: 2 year(s) Reference Life (BOMA): 20 year(s) </p>
		<p> Description: Modified bituminous roofing system with a fluid applied reflective top coating Critical Issues: The top coating is starting to deteriorate and fail, evidence of coatings on the cedar shingles at scuppers. The bituminous membrane has several areas that are cracking and deteriorated. There is debris on the mansard roof valleys. Recommendations: Initiate a periodic maintenance program to clear the scuppers and gutters, remove debris, and monitor the condition of the roof. Repair damaged areas of the bituminous roofing and apply a new layer of reflective top coating. Repair Factor: 22% </p> <p style="text-align: right;">Pricing Unit: 8,300 SF Cost: \$80,192</p>

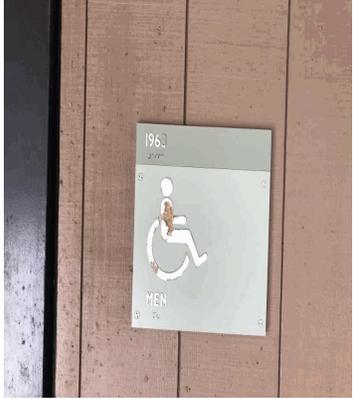
<p> FOScore #: 801610 Uniformat Name: H2010 - ADA Assessments Category: Accessibility Standards - Location: Entire Building Area Served: Entire Building Observed Remaining Life: 2 year(s) Act By: 2023 Action Timeframe: 2 year(s) Reference Life (BOMA): 75 year(s) </p>
		<p> Description: General accessibility observation of 5-points Critical Issues: Accessibility features for this facility were observed to be either partially or fully non-compliant with the applicable scoping provisions and current accessibility standards which may include, but are not limited to, interior and exterior accessible routes, restrooms, communication systems, drinking fountains, occupancy controls, fixed furnishings, doors and door hardware, handrails and guards, wayfinding and signage systems, walkways, and vehicular parking areas. Recommendations: Consider a comprehensive accessibility study for remedial recommendations and compliance with the current applicable accessibility standards. Associated action cost is an allowance for the accessibility study for this recommendation based on the building square footage and/or minimum cost of assessment. Action cost represents a rough order of magnitude cost. Actual cost will be provided based on detailed programmatic requirements provided by the client. Repair Factor: 100% </p> <p style="text-align: right;">Pricing Unit: 1 EA Cost: \$7,410</p>

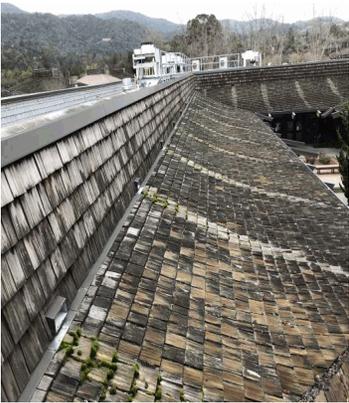
<p> FOScore #: 796331 Uniformat Name: B3010 - Roofing - Cedar Shingles Category: Building Integrity - Reliability Location: Roof Area Served: Entire Building Observed Remaining Life: 3 year(s) Act By: 2024 Action Timeframe: 3 year(s) Reference Life (BOMA): 20 year(s) </p>
	<p> Description: Cedar shingle roofing Critical Issues: The shingles appear to be moderately deteriorated throughout but are more severely deteriorated beneath the scuppers from the upper roof where heavy organic growth was observed. Recommendations: Replace the cedar shingle roofing. Repair Factor: 100% </p> <p style="text-align: right;">Pricing Unit: 23,820 SF Cost: \$512,162</p>	
P R I O R I T Y 3

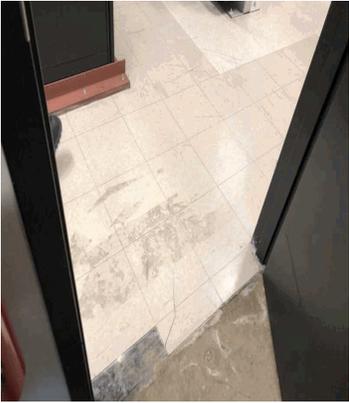
<p> FOScore #: 793789 Uniformat Name: C2030 - Vinyl Composition Tile Flooring Category: Building Integrity - Appearance Location: Partial Building Area Served: Breakrooms and Information Tech. Rooms Observed Remaining Life: 13 year(s) Act By: 2025 Action Timeframe: 4 year(s) Reference Life (BOMA): 12 year(s) </p>

<p> Description: Vinyl Composite Tile (VCT) Flooring Critical Issues: Damaged and missing tile were observed. Recommendations: Replace the damaged VCT flooring. Consider removing the VCT flooring and adhesive from the mechanical and IT rooms and sealing the concrete slabs beneath. Repair Factor: 40% </p> <p style="text-align: right;">Pricing Unit: 790 SF Cost: \$2,139</p>

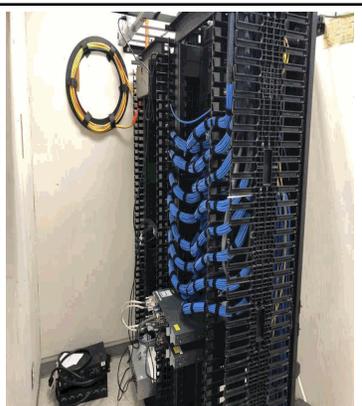
<p>FOScore #: 794192 Uniformat Name: D6010 - Data Communications Category: Building Integrity - Reliability Location: Entire Building Area Served: Entire Building Observed Remaining Life: 10 year(s) Act By: 2024 Action Timeframe: 3 year(s) Reference Life (BOMA): 20 year(s)</p> <hr/> <p>Description: The building has a voice and data network consisting of structured equipment boards, cable racks, wiring systems, WIFI, and outlets that are maintained by an internal IT department. .A wired phone system is present. Critical Issues: Insufficient card reader access, door sweeps, and sealing of conduit in the IT rooms 1911 and 1944. As technology advances and equipment ages upgrades to the systems will be required. Recommendations: Upgrade card reader access, door sweeps, and properly seal wall penetrations and conduit as required. Upgrade the data and voice cabling systems throughout the facility in accordance with the facility's needs and equipment demands as remodeling and upgrades are accomplished. Repair Factor: 10%</p> <p style="text-align: right;">Pricing Unit: 22,851 BGSF Cost: \$24,976</p>

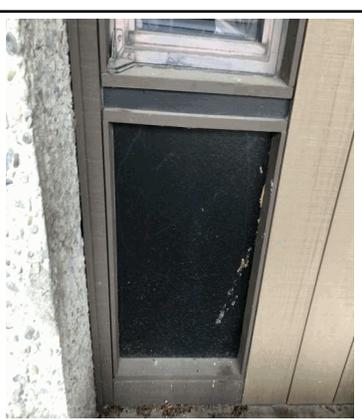
<p>FOScore #: 793583 Uniformat Name: B2010 - Exterior Coatings Category: Building Integrity - Appearance Location: Building Exterior Area Served: Building Exterior Observed Remaining Life: 7 year(s) Act By: 2028 Action Timeframe: 7 year(s) Reference Life (BOMA): 10 year(s)</p> <hr/> <p>Description: Painted wood siding, overhangs, soffits, fascias, window trim, louvers, and doors. Critical Issues: The paint finishes are moderately deteriorated throughout the exterior of the building and can be expected to require repainting within the scope of this report based on the anticipated rate of deterioration. Recommendations: Prepare surfaces and apply new finishes to the painted exterior elements of the building. Replace elastomeric sealants around wall penetrations as needed. Repair Factor: 100%</p> <p style="text-align: right;">Pricing Unit: 22,851 BGSF Cost: \$84,663</p>

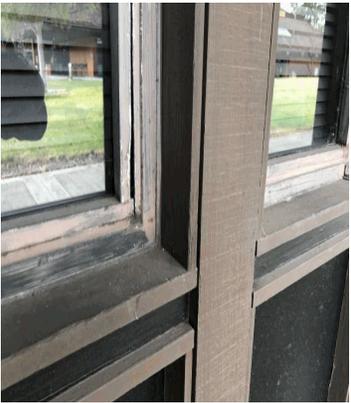
<p>FOScore #: 793524 Uniformat Name: B2020 - Exterior Windows Category: Building Integrity - Reliability Location: Building Exterior Area Served: Building Exterior Observed Remaining Life: 10 year(s) Act By: 2031 Action Timeframe: 10 year(s) Reference Life (BOMA): 30 year(s)</p>
		<p>Description: Exterior windows include wood-frame casement windows, fixed transoms wood windows with single-pane glazing Critical Issues: The windows have thermally inefficient single-pane glazing. Many of the windows have deteriorated frame elements. Recommendations: Replace the windows with a high-performance energy-efficient system. Repair Factor: 100%</p> <p style="text-align: right;">Pricing Unit: 1,500 WSF Cost: \$132,454</p>
<p>P R I O R I T Y 4</p>

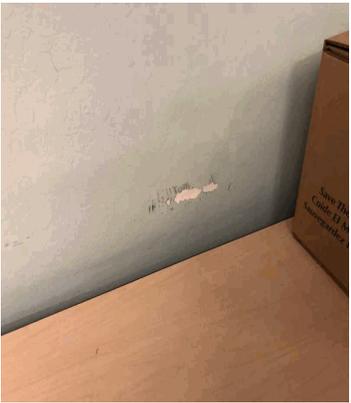
<p>FOScore #: 793774 Uniformat Name: C1010 - Interior Coatings Category: Building Integrity - Appearance Location: Partial Building Area Served: Various Areas Observed Remaining Life: 9 year(s) Act By: 2030 Action Timeframe: 9 year(s) Reference Life (BOMA): 100 year(s)</p>

<p>Description: Interior coatings consist of painted plaster/gypsum wallboard, wood surfaces, window and door casement, and wood baseboard moldings Critical Issues: Minor surface damage was observed on the plaster/gypsum wallboard surfaces throughout the building. The interior painted surfaces of the building can be expected to require repair and repainting within the scope of this report. Recommendations: Repair minor wall surface damage under scheduled maintenance project in the mailroom. Apply new finish coatings within the prescribed action time frame. Repair Factor: 100%</p> <p style="text-align: right;">Pricing Unit: 22,851 BGSF Cost: \$98,773</p>

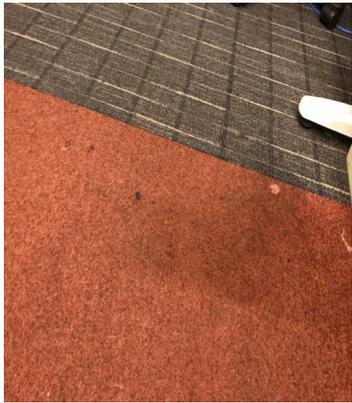
<p> FOScore #: 793766 Uniformat Name: C2030 - Carpeting Category: Building Integrity - Appearance Location: Partial Building Area Served: Offices, Classrooms, and Hallways Observed Remaining Life: 7 year(s) Act By: 2028 Action Timeframe: 7 year(s) Reference Life (BOMA): 5 year(s) </p>
		<p> Description: Sheet and tile Carpeting Critical Issues: The carpeting is moderately worn with stains and traffic pattern registration in a number of areas. Recommendations: Replace the carpeting. Repair Factor: 100% </p> <p style="text-align: right;">Pricing Unit: 16,951 SF Cost: \$97,555</p>
P R I O R I T Y 4

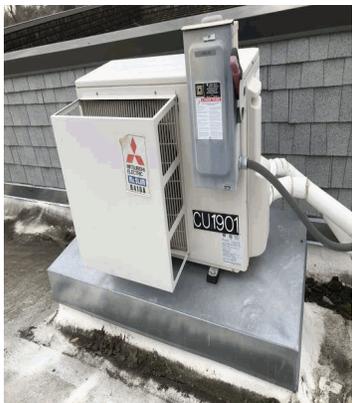
<p> FOScore #: 793943 Uniformat Name: D3040 - Split-System Air Conditioners Category: Operations - Maintenance Location: Entire Building Area Served: Entire Building Observed Remaining Life: 9 year(s) Act By: 2030 Action Timeframe: 9 year(s) Reference Life (BOMA): 15 year(s) </p>

<p> Description: Split system air conditioning unit with an indoor evaporator and remote air-cooled condensing unit, includes refrigeration piping and insulation. Critical Issues: No critical issues observed or reported other than normal aging, the equipment appears to be well maintained. However, the equipment will be due for replacement within the time frame of this report. Recommendations: Monitor for characteristics inconsistent with normal operation, recurring and/or increasing maintenance repair needs. Replace the equipment within the action timeframe. Repair Factor: 100% </p> <p style="text-align: right;">Pricing Unit: 1 EA Cost: \$9,966</p>

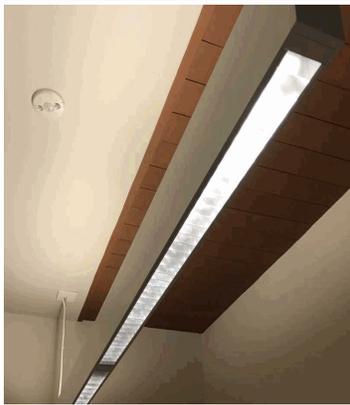
FOScore #: 794205
Uniformat Name: D5040 - Interior Lighting
Category: Operations - Energy
Location: Entire Building
Area Served: Entire Building
Observed Remaining Life: 15 year(s)
Act By: 2031
Action Timeframe: 10 year(s)
Reference Life (BOMA): 30 year(s)

Description: Interior lighting consists mainly of pendant-mounted, surface-mounted fluorescent fixtures along with track lighting with incandescent lamps which are controlled using light switches, occupancy sensors, and lighting control panels. There are other light fixture types that exist in smaller quantities. Exit signs are green or red letters with a white or brushed aluminum background, some contain integral battery backup and emergency lighting. Emergency lighting is also accomplished with wall-mounted egress lighting with integral battery backup.

Critical Issues: The lighting systems have been updated recently with new fluorescent fixtures. No deficiencies or negative impact issues observed.

Recommendations: Consider a program to replace all fluorescent lamps with new LED-type lamps, especially as the fluorescent lamps and/or ballasts fail and need replacement or during other renovations.

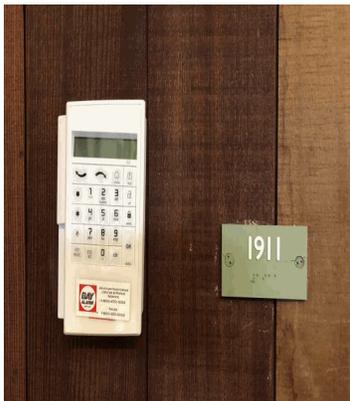
FOScore #: 794215
Uniformat Name: D7010 - Access Control and Intrusion Detection
Category: Operations - Security
Location: Entire Building
Area Served: Entire Building
Observed Remaining Life: 6 year(s)
Act By: 2027
Action Timeframe: 6 year(s)
Reference Life (BOMA): 10 year(s)

Description: Access control and intrusion detection consist of keyed door locks and motion detectors routed through a monitored security panel to a wall-mounted controller.

Critical Issues: No deficiencies or negative impact issues observed however, as technology advances and equipment ages, upgrades to the systems will be required.

Recommendations: Upgrade the system equipment, cabling, and devices throughout the building in accordance with the needs of the facility and as equipment demands, or as remodeling and upgrades are accomplished. Consider installing proximity card readers for added security.

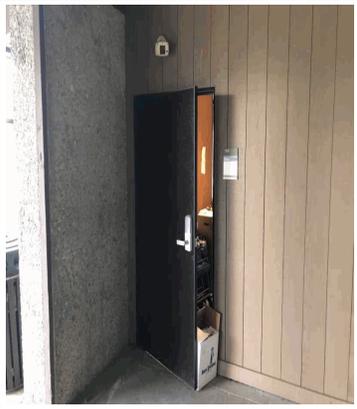
<p>FOScore #: 794219 Uniformat Name: D7030 - Electronic Surveillance Category: Operations - Security Location: Building Exterior Area Served: Exterior Observed Remaining Life: 6 year(s) Act By: 2027 Action Timeframe: 6 year(s) Reference Life (BOMA): 10 year(s)</p>
		<p>Description: The system consists of security surveillance cameras located on the exterior of the building that is routed to a central system. Critical Issues: As technology advances and equipment ages, upgrades to the surveillance systems will be required. No other deficiencies or negative impact issues observed. Recommendations: Upgrade the cabling systems and end devices throughout the facility per the needs of the facility and equipment demands or as remodeling and upgrades are accomplished. Repair Factor: 100%</p> <p style="text-align: right;">Pricing Unit: 22,851 BGSF Cost: \$29,632</p>
<p>P R I O R I T Y 4</p>

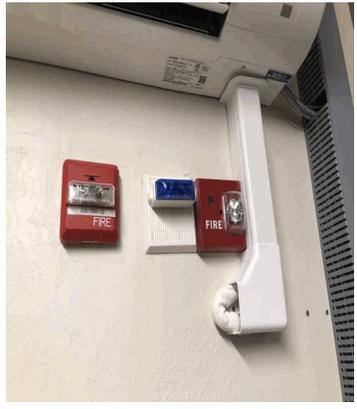
<p>FOScore #: 794217 Uniformat Name: D7050 - Fire Detection and Alarm Category: Operations - Security Location: Entire Building Area Served: Entire Building Observed Remaining Life: 8 year(s) Act By: 2029 Action Timeframe: 8 year(s) Reference Life (BOMA): 10 year(s)</p>

<p>Description: Fire detection and alarm consist of the main fire alarm panel located in Building 6000, horn/strobes, heat/smoke detectors, extender panels, and wiring. Critical Issues: No deficiencies or negative impact issues observed however, as technology advances and equipment ages, upgrades to the systems will be required. Recommendations: Continue to perform the manufacturer's recommended testing. Upgrade and/or replace the system components as necessary to ensure early detection of a fire and to allow maximum evacuation time and limited damage. Repair Factor: 50%</p> <p style="text-align: right;">Pricing Unit: 22,851 BGSF Cost: \$35,276</p>

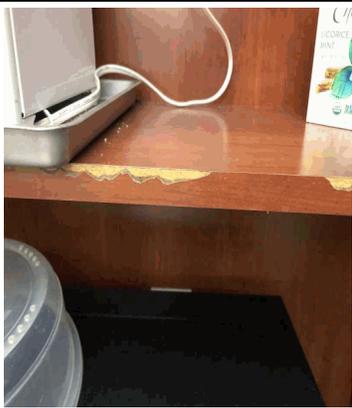
FOScore #: 793665
Uniformat Name: E2010 - Fixed Furnishings
Category: Building Integrity - Appearance
Location: Partial Building
Area Served: Breakrooms and Office Areas
Observed Remaining Life: 16 year(s)
Act By: 2028
Action Timeframe: 7 year(s)
Reference Life (BOMA): 15 year(s)

Description: Interior fixed furnishings consist of plastic laminate countertops, plastic laminate base cabinetry, and plastic laminate wall cabinetry.
Critical Issues: Damaged plastic laminate finishes were observed.
Recommendations: Replace deteriorated cabinets and countertop system within the prescribed action timeframe.
Repair Factor: 25%

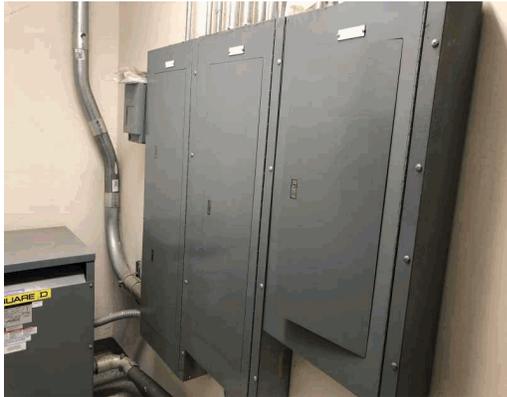
Item #: 794199
Uniformat Number: D5020
Item Title: Arc Flash Hazard Analysis and Short Circuit Coordination
Caption: No arc flash hazard stickers
Priority: 1 - Currently Critical

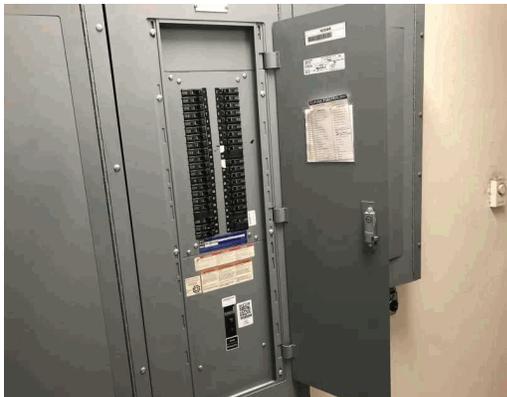
Item #: 794199
Uniformat Number: D5020
Item Title: Arc Flash Hazard Analysis and Short Circuit Coordination
Caption: No arc flash hazard stickers
Priority: 1 - Currently Critical

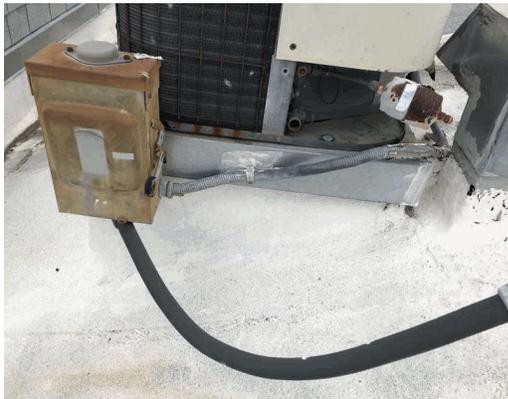
Item #: 794207
Uniformat Number: D5080
Item Title: Miscellaneous Electrical Systems (Mech Connections)
Caption: Weathered components
Priority: 1 - Currently Critical

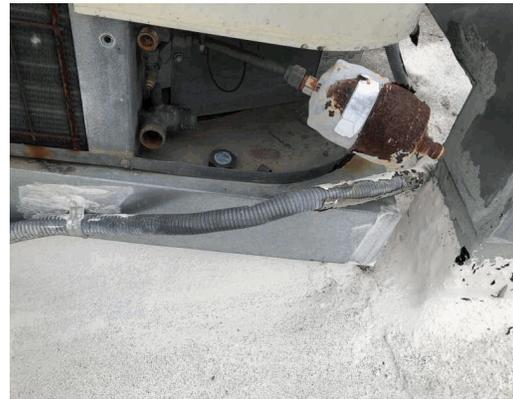
Item #: 794207
Uniformat Number: D5080
Item Title: Miscellaneous Electrical Systems (Mech Connections)
Caption: Weathered components
Priority: 1 - Currently Critical

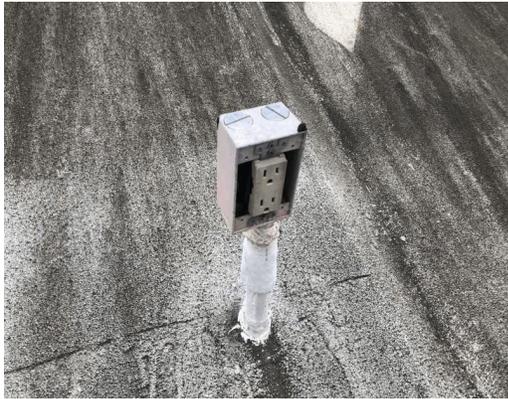
Item #: 794207
Uniformat Number: D5080
Item Title: Miscellaneous Electrical Systems (Mech Connections)
Caption: Weather-proof receptacle
Priority: 1 - Currently Critical

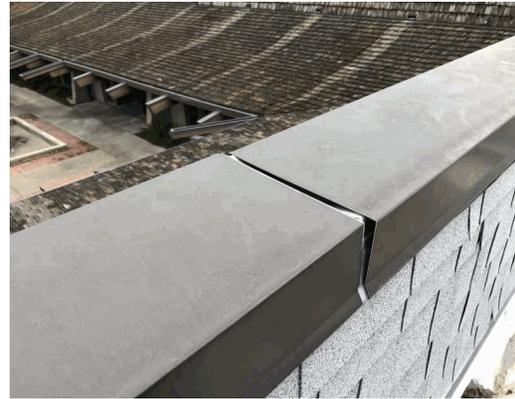
Item #: 796334
Uniformat Number: B2080
Item Title: Exterior Metal Fabrications
Caption: Copings
Priority: 2 - Potentially Critical

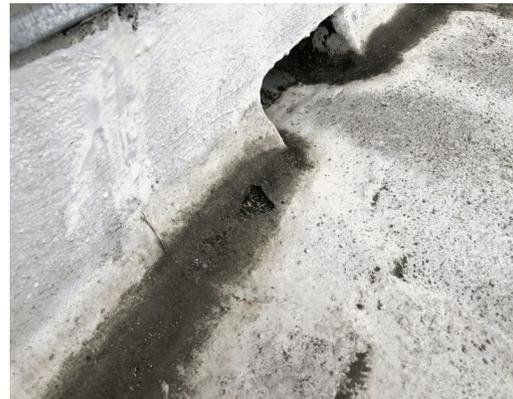
Item #: 793508
Uniformat Number: B3010
Item Title: Roofing Membrane
Caption: Roofing Membrane - Membrane Hole
Priority: 2 - Potentially Critical

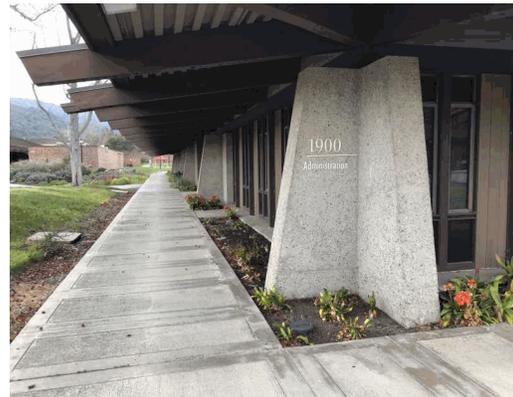
Item #: 801610
Uniformat Number: H2010
Item Title: ADA Assessments
Caption: ADA Accessibility - Walkways
Priority: 2 - Potentially Critical

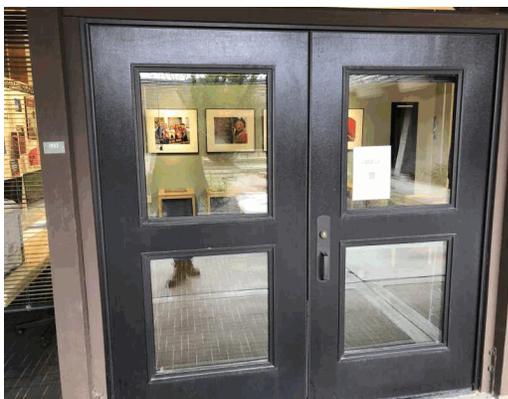
Item #: 801610
Uniformat Number: H2010
Item Title: ADA Assessments
Caption: ADA Accessibility - Front Entrance Door
Priority: 2 - Potentially Critical

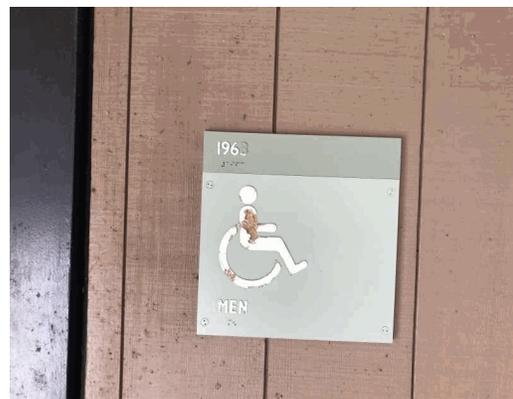
Item #: 801610
Uniformat Number: H2010
Item Title: ADA Assessments
Caption: ADA Accessibility - Exterior Signage
Priority: 2 - Potentially Critical

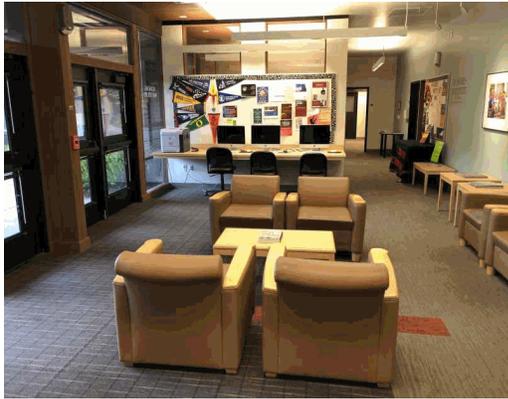
Item #: 801610
Uniformat Number: H2010
Item Title: ADA Assessments
Caption: ADA Accessibility - Main Lobby
Priority: 2 - Potentially Critical

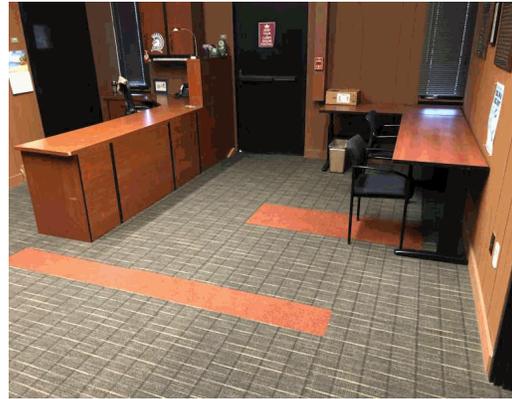
Item #: 801610
Uniformat Number: H2010
Item Title: ADA Assessments
Caption: ADA Accessibility - Cabinetry
Priority: 2 - Potentially Critical

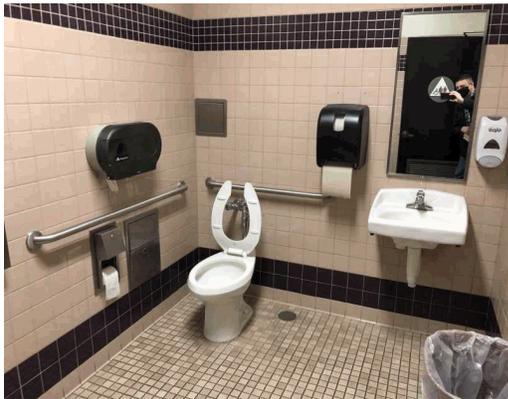
Item #: 801610
Uniformat Number: H2010
Item Title: ADA Assessments
Caption: ADA Accessibility - Restrooms
Priority: 2 - Potentially Critical

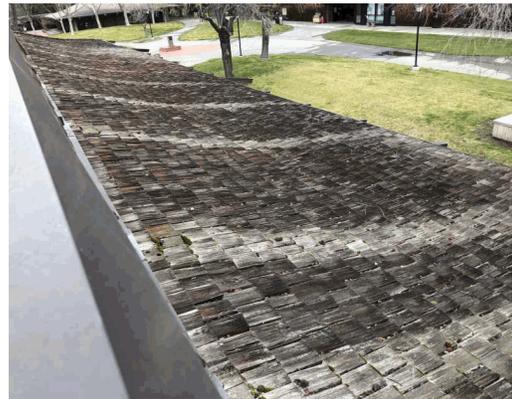
Item #: 796331
Uniformat Number: B3010
Item Title: Roofing - Cedar Shingles
Caption: Organic growth at scuppers
Priority: 3 - Necessary - Not Yet Critical

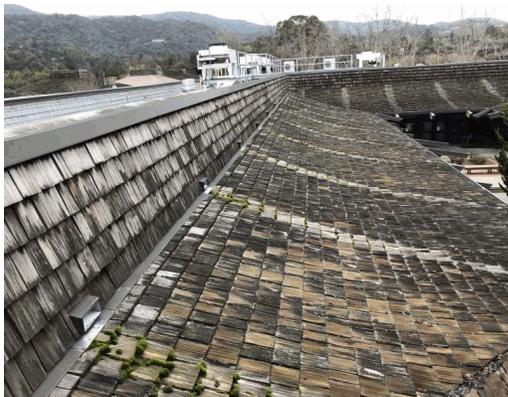
Item #: 796331
Uniformat Number: B3010
Item Title: Roofing - Cedar Shingles
Caption: Organic growth at scuppers
Priority: 3 - Necessary - Not Yet Critical

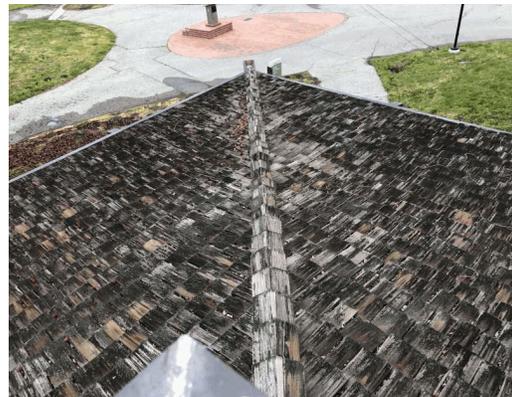
Item #: 796331
Uniformat Number: B3010
Item Title: Roofing - Cedar Shingles
Caption: Cedar shingle roofing
Priority: 3 - Necessary - Not Yet Critical

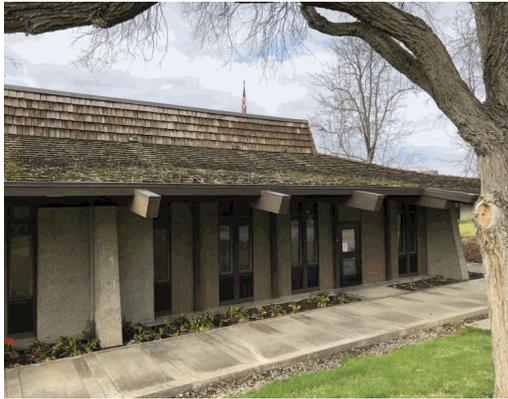
Item #: 796331
Uniformat Number: B3010
Item Title: Roofing - Cedar Shingles
Caption: Organic growth - East elevation
Priority: 3 - Necessary - Not Yet Critical

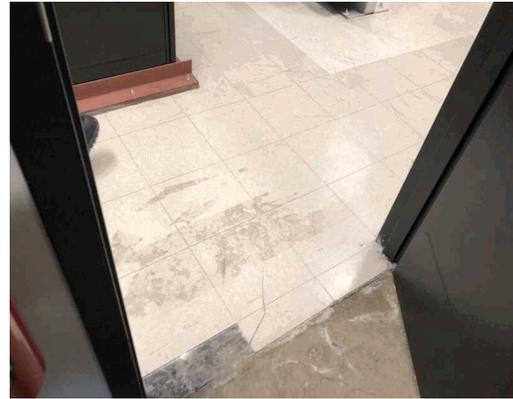
Item #: 793789
Uniformat Number: C2030
Item Title: Vinyl Composition Tile Flooring
Caption: Vinyl Composition Tile Flooring - Room # 1909 IT Room
Priority: 3 - Necessary - Not Yet Critical

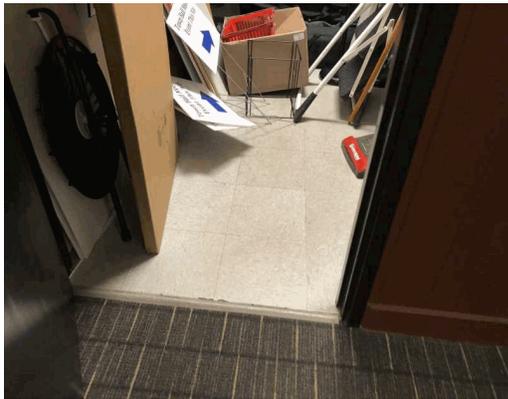
Item #: 793789
Uniformat Number: C2030
Item Title: Vinyl Composition Tile Flooring
Caption: Vinyl Composition Tile Flooring - Room # 1903 Janitorial
Priority: 3 - Necessary - Not Yet Critical

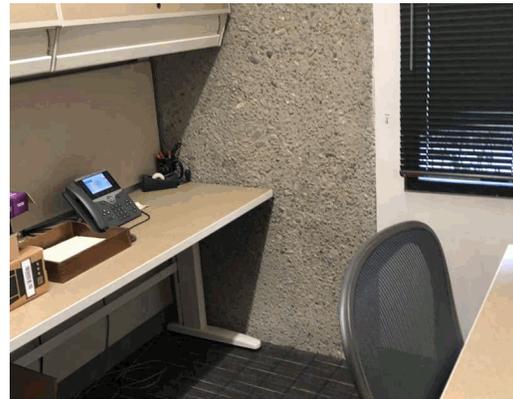
Item #: 794192
Uniformat Number: D6010
Item Title: Data Communications
Caption: Phone
Priority: 3 - Necessary - Not Yet Critical

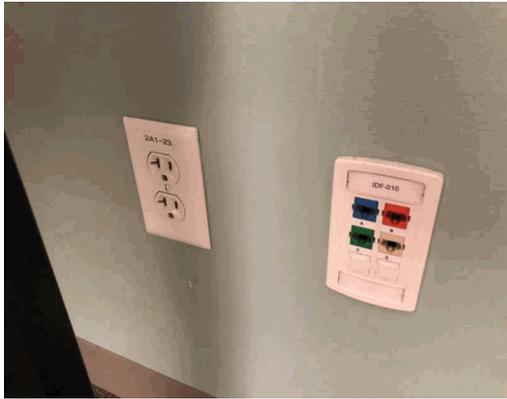
Item #: 794192
Uniformat Number: D6010
Item Title: Data Communications
Caption: Datacom outlets
Priority: 3 - Necessary - Not Yet Critical

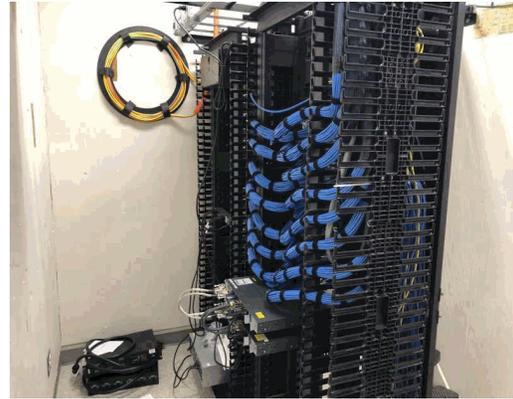
Item #: 794192
Uniformat Number: D6010
Item Title: Data Communications
Caption: Equipment racks
Priority: 3 - Necessary - Not Yet Critical

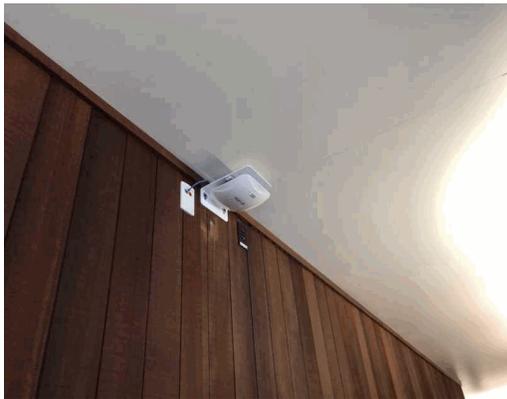
Item #: 794192
Uniformat Number: D6010
Item Title: Data Communications
Caption: Wifi router
Priority: 3 - Necessary - Not Yet Critical

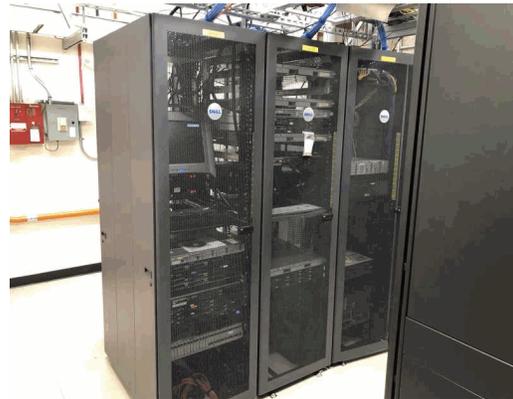
Item #: 794192
Uniformat Number: D6010
Item Title: Data Communications
Caption: Equipment racks
Priority: 3 - Necessary - Not Yet Critical

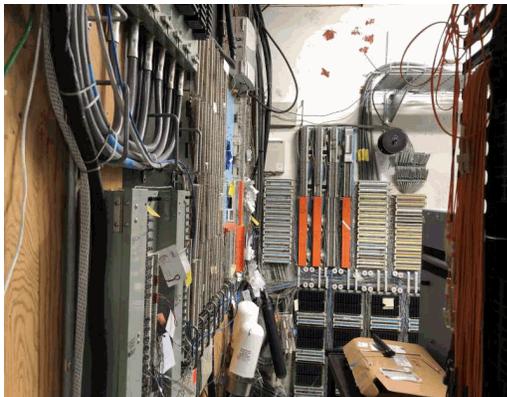
Item #: 794192
Uniformat Number: D6010
Item Title: Data Communications
Caption: Datacom wiring
Priority: 3 - Necessary - Not Yet Critical

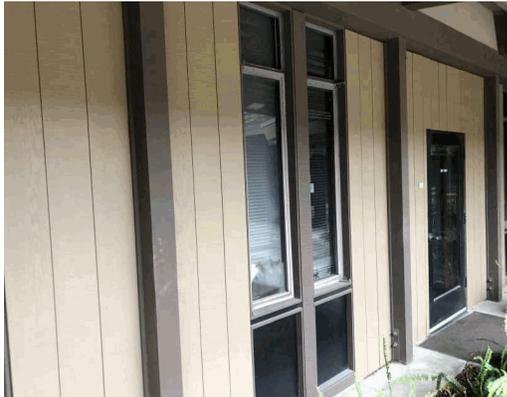
Item #: 793524
Uniformat Number: B2020
Item Title: Exterior Windows
Caption: Exterior Windows - Typical
Priority: 4 - Recommended

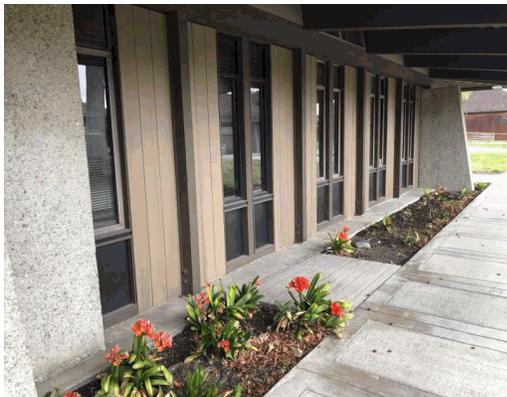
Item #: 793524
Uniformat Number: B2020
Item Title: Exterior Windows
Caption: Exterior Windows - Typical
Priority: 4 - Recommended

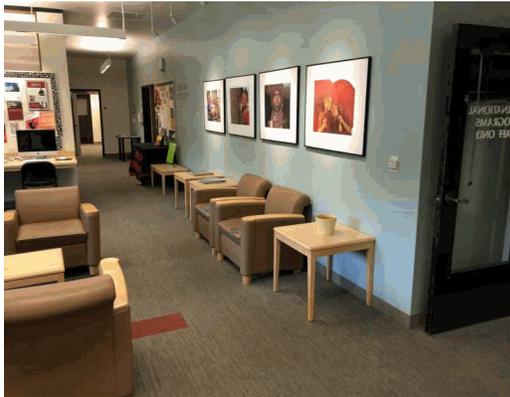
Item #: 793774
Uniformat Number: C1010
Item Title: Interior Coatings
Caption: Interior Coatings - International Programs Lobby
Priority: 4 - Recommended

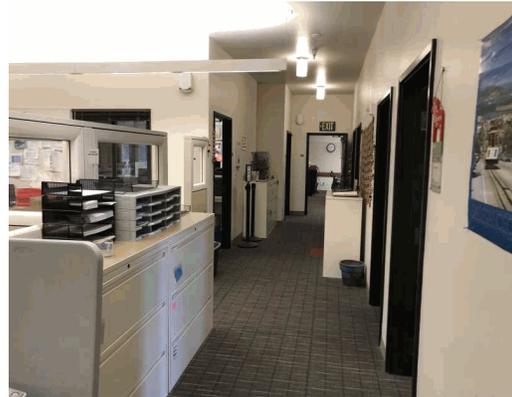
Item #: 793774
Uniformat Number: C1010
Item Title: Interior Coatings
Caption: Interior Coatings - Room # 1939
Priority: 4 - Recommended

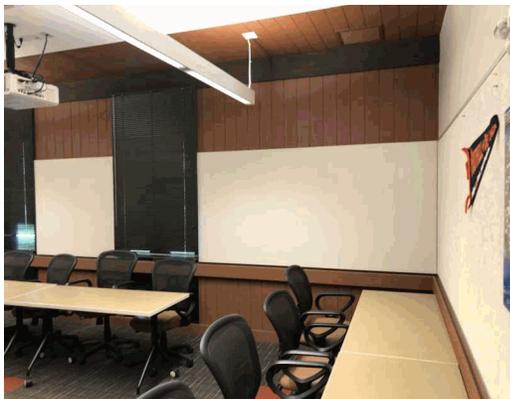
Item #: 793774
Uniformat Number: C1010
Item Title: Interior Coatings
Caption: Interior Coatings - Room # 1943
Priority: 4 - Recommended

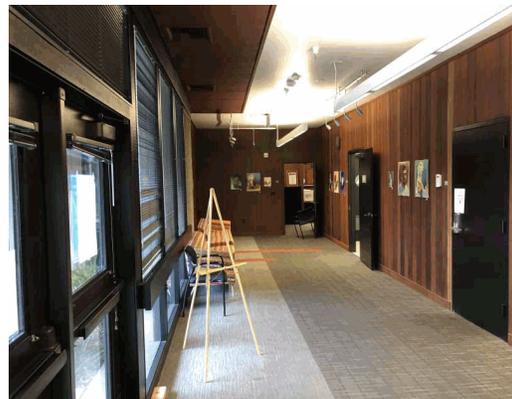
Item #: 793774
Uniformat Number: C1010
Item Title: Interior Coatings
Caption: Interior Coatings - Administration Office Lobby
Priority: 4 - Recommended

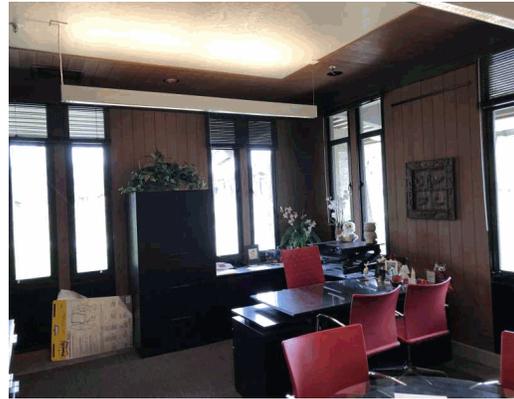
Item #: 793774
Uniformat Number: C1010
Item Title: Interior Coatings
Caption: Interior Coatings - Room # 1904
Priority: 4 - Recommended

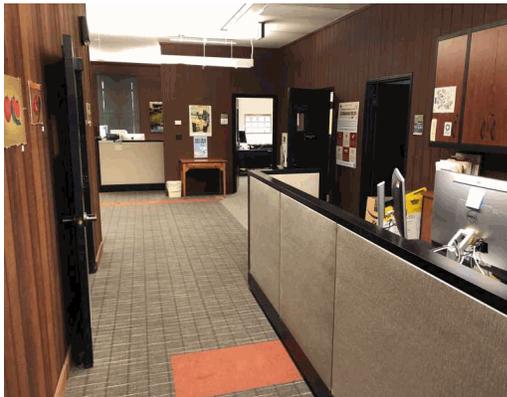
Item #: 793774
Uniformat Number: C1010
Item Title: Interior Coatings
Caption: Interior Coatings - Hallway
Priority: 4 - Recommended

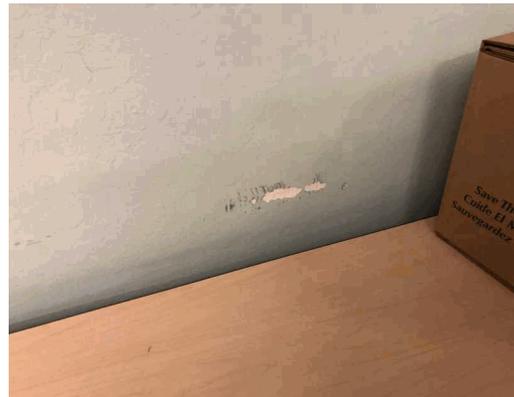
Item #: 793774
Uniformat Number: C1010
Item Title: Interior Coatings
Caption: Interior Coatings - Mail Room
Priority: 4 - Recommended

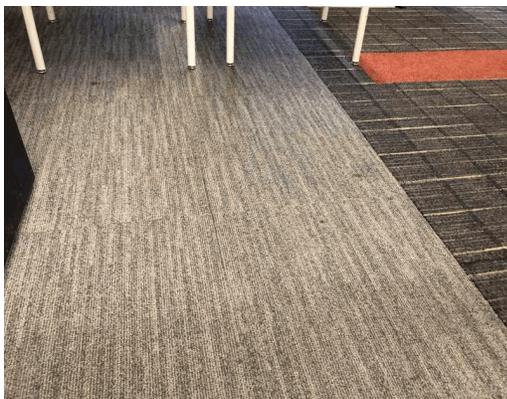
Item #: 793766
Uniformat Number: C2030
Item Title: Carpeting
Caption: Tile Carpeting - Room # 1936
Priority: 4 - Recommended

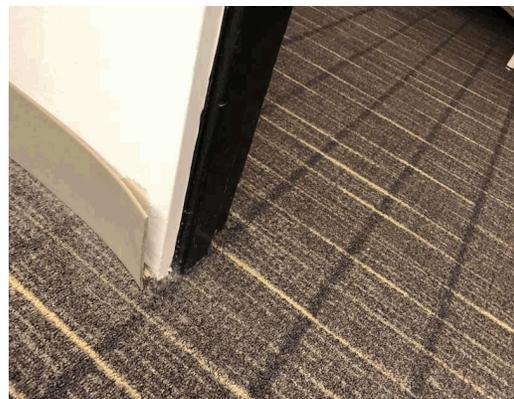
Item #: 793766
Uniformat Number: C2030
Item Title: Carpeting
Caption: Tile Carpeting - Room # 1946
Priority: 4 - Recommended

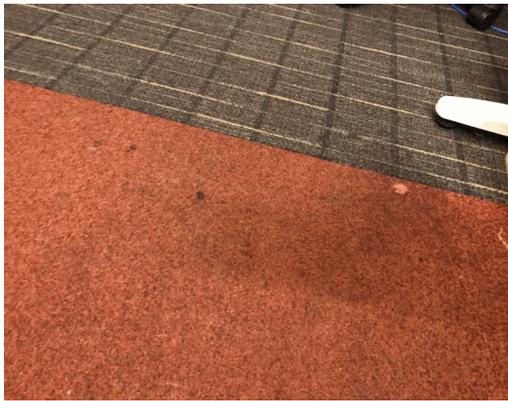
Item #: 793766
Uniformat Number: C2030
Item Title: Carpeting
Caption: Tile Carpeting - Room # 1948
Priority: 4 - Recommended

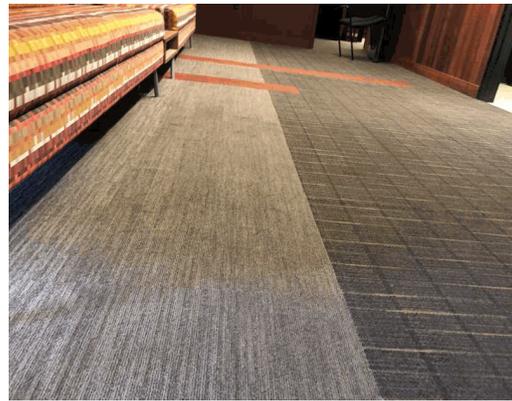
Item #: 793766
Uniformat Number: C2030
Item Title: Carpeting
Caption: Tile Carpeting - Lobby Area
Priority: 4 - Recommended

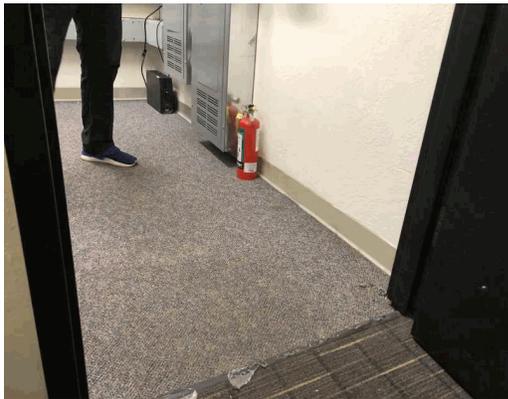
Item #: 793766
Uniformat Number: C2030
Item Title: Carpeting
Caption: Sheet Carpeting - Room # 1907
Priority: 4 - Recommended

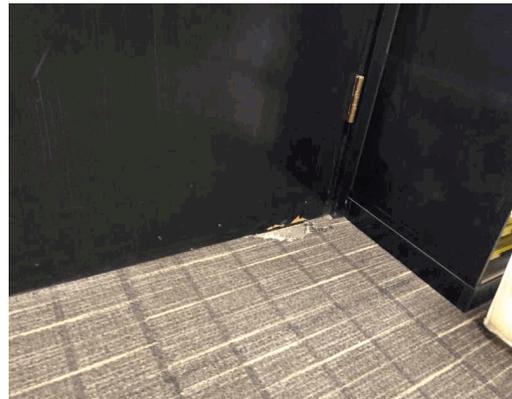
Item #: 793766
Uniformat Number: C2030
Item Title: Carpeting
Caption: Tile Carpeting - Mail Room
Priority: 4 - Recommended

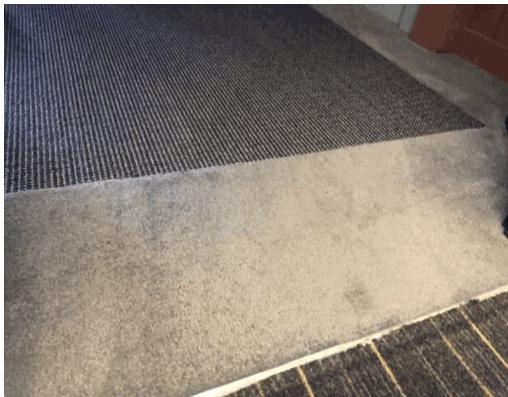
Item #: 793766
Uniformat Number: C2030
Item Title: Carpeting
Caption: Tile Carpeting - Room # 1904
Priority: 4 - Recommended

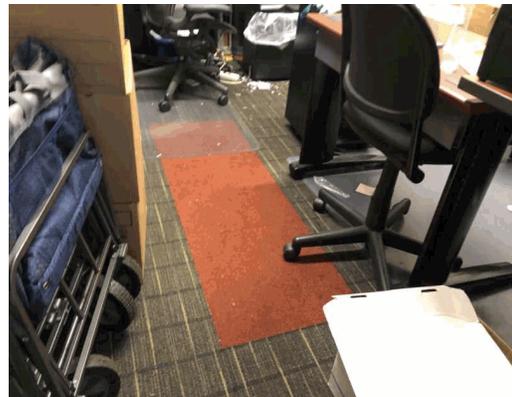
Item #: 793766
Uniformat Number: C2030
Item Title: Carpeting
Caption: Tile Carpeting - Room # 1928
Priority: 4 - Recommended

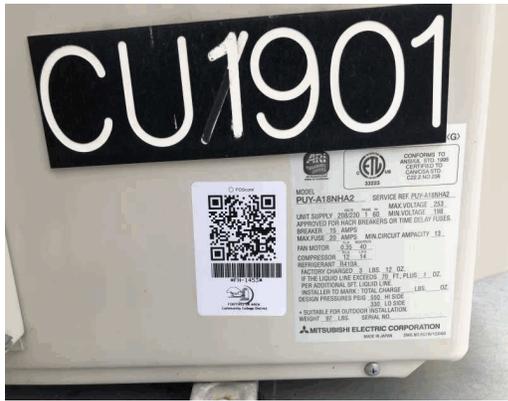
Item #: 793943
Uniformat Number: D3040
Item Title: Split-System Air Conditioners
Caption: Nameplate
Priority: 4 - Recommended

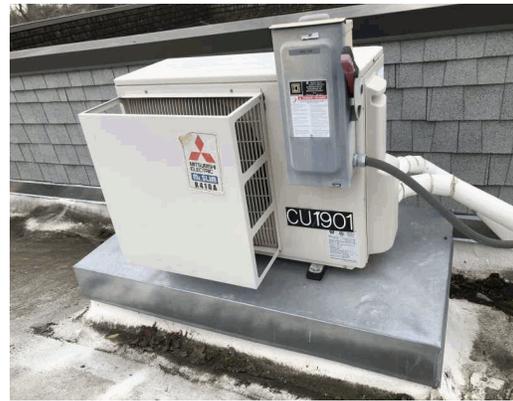
Item #: 793943
Uniformat Number: D3040
Item Title: Split-System Air Conditioners
Caption: Split system air-cooled condensing unit
Priority: 4 - Recommended

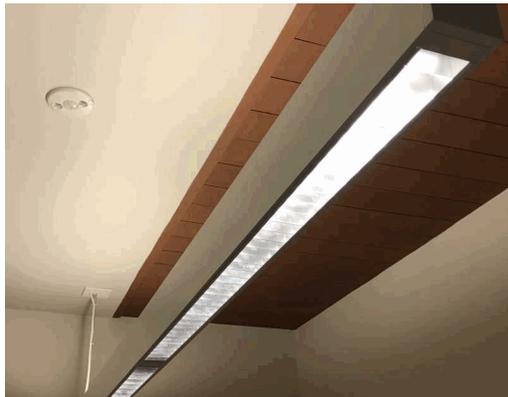
Item #: 794205
Uniformat Number: D5040
Item Title: Interior Lighting
Caption: Pendant-mounted light fixtures
Priority: 4 - Recommended

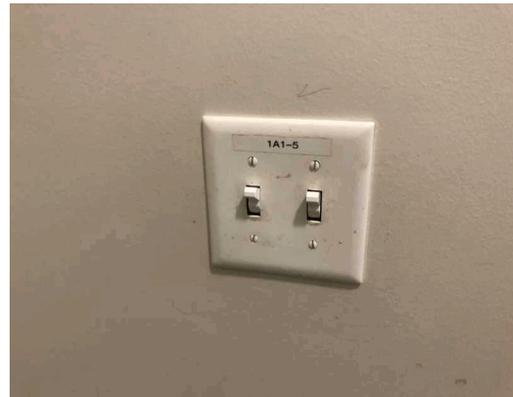
Item #: 794205
Uniformat Number: D5040
Item Title: Interior Lighting
Caption: Wall switches
Priority: 4 - Recommended

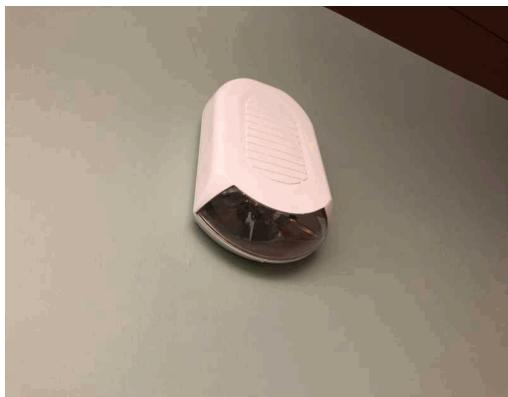
Item #: 794205
Uniformat Number: D5040
Item Title: Interior Lighting
Caption: Emergency egress light
Priority: 4 - Recommended

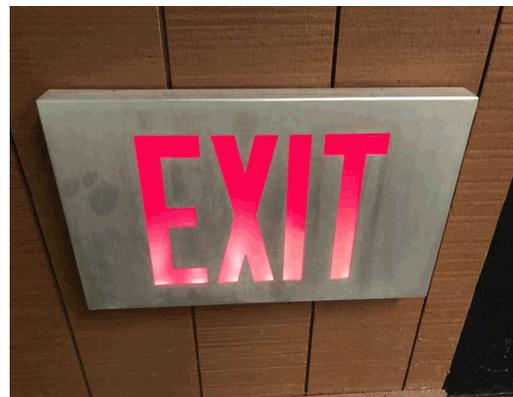
Item #: 794205
Uniformat Number: D5040
Item Title: Interior Lighting
Caption: Exit sign
Priority: 4 - Recommended

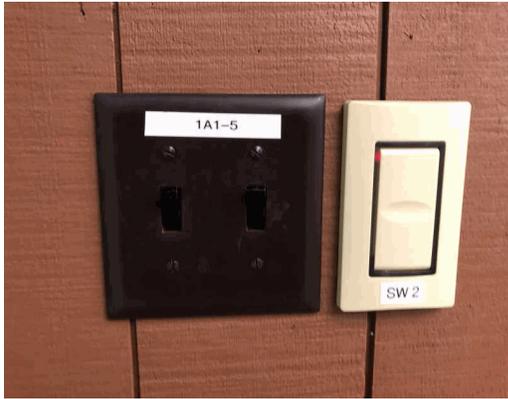
Item #: 794205
Uniformat Number: D5040
Item Title: Interior Lighting
Caption: Wall switches
Priority: 4 - Recommended

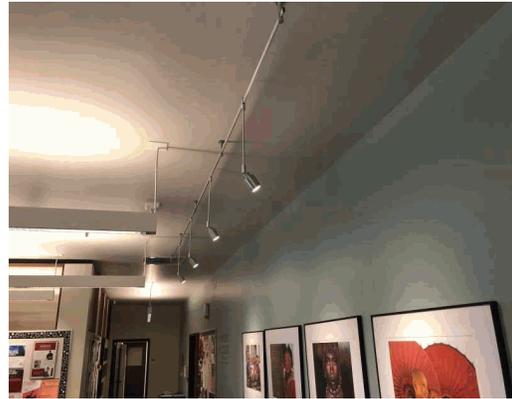
Item #: 794205
Uniformat Number: D5040
Item Title: Interior Lighting
Caption: Track lighting
Priority: 4 - Recommended

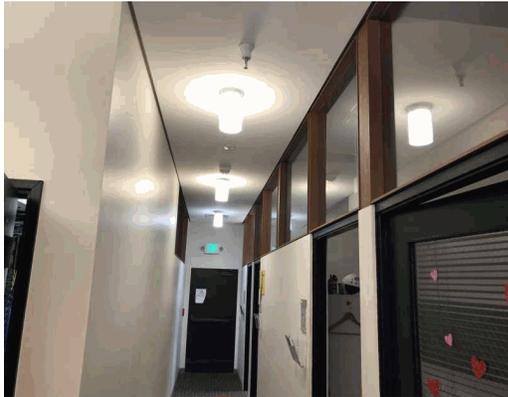
Item #: 794205
Uniformat Number: D5040
Item Title: Interior Lighting
Caption: Surface-mounted CFL fixtures
Priority: 4 - Recommended

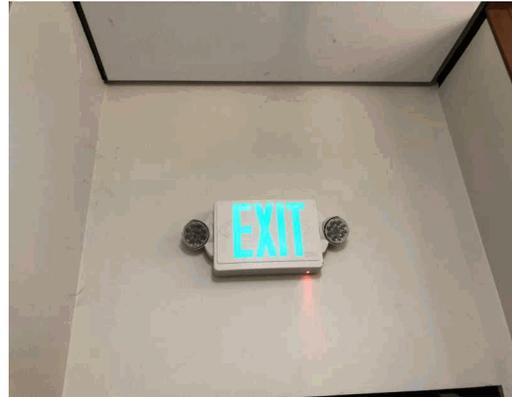
Item #: 794205
Uniformat Number: D5040
Item Title: Interior Lighting
Caption: Exit sign
Priority: 4 - Recommended

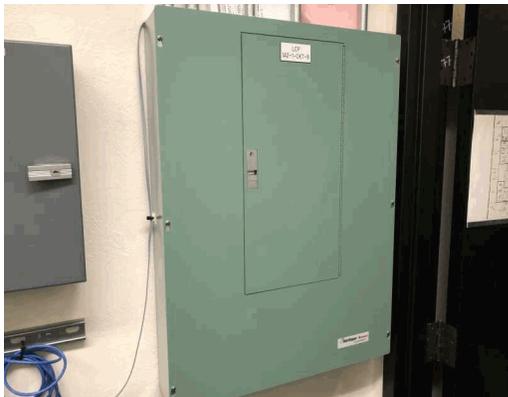
Item #: 794205
Uniformat Number: D5040
Item Title: Interior Lighting
Caption: Lighting control panel
Priority: 4 - Recommended

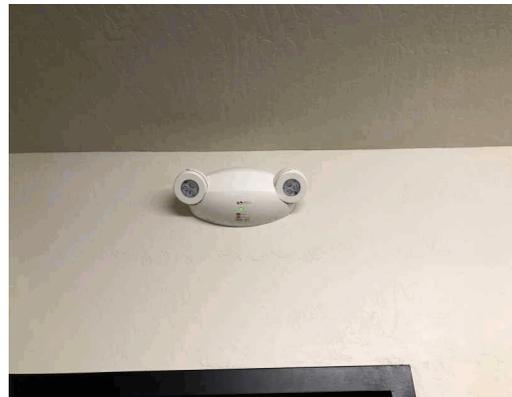
Item #: 794205
Uniformat Number: D5040
Item Title: Interior Lighting
Caption: Emergency egress light
Priority: 4 - Recommended

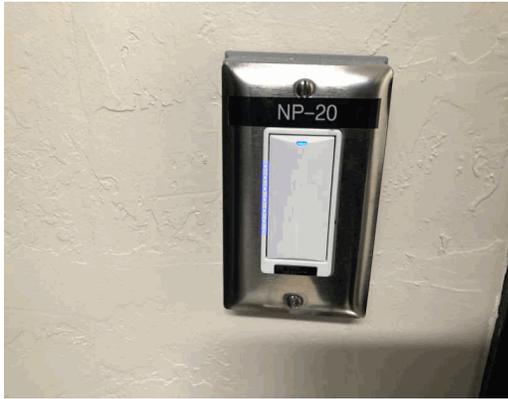
Item #: 794205
Uniformat Number: D5040
Item Title: Interior Lighting
Caption: Dimmer switch
Priority: 4 - Recommended

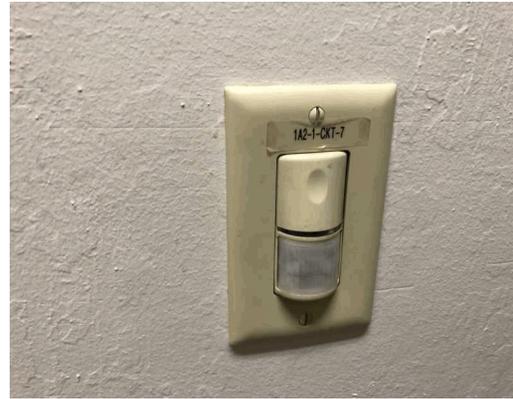
Item #: 794205
Uniformat Number: D5040
Item Title: Interior Lighting
Caption: Occupancy sensor switch
Priority: 4 - Recommended

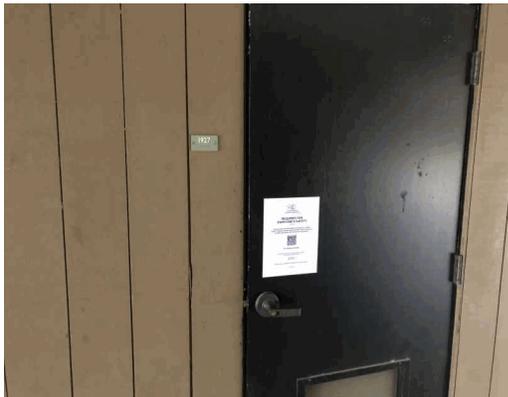
Item #: 794215
Uniformat Number: D7010
Item Title: Access Control and Intrusion Detection
Caption: Keyed door lock
Priority: 4 - Recommended

794215	D7010 Access Control and Intrusion Detection	Access control and intrusion detection consist of keyed door locks and motion detectors routed through a monitored security panel to a wall-mounted controller.	No deficiencies or negative impact issues observed however, as technology advances and equipment ages, upgrades to the systems will be required.	Upgrade the system equipment, cabling, and devices throughout the building in accordance with the needs of the facility and as equipment demands, or as remodeling and upgrades are accomplished. Consider installing proximity card readers for added security.	4	6	10	\$21,166
794219	D7030 Electronic Surveillance	The system consists of security surveillance cameras located on the exterior of the building that is routed to a central system.	As technology advances and equipment ages, upgrades to the surveillance systems will be required. No other deficiencies or negative impact issues observed.	Upgrade the cabling systems and end devices throughout the facility per the needs of the facility and equipment demands or as remodeling and upgrades are accomplished.	4	6	10	\$29,632

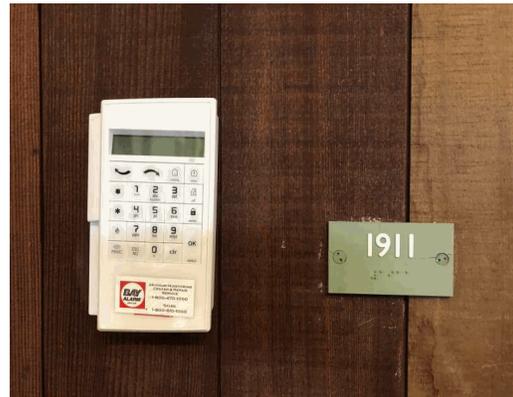
Item #: 794215
Uniformat Number: D7010
Item Title: Access Control and Intrusion Detection
Caption: Security keypad
Priority: 4 - Recommended

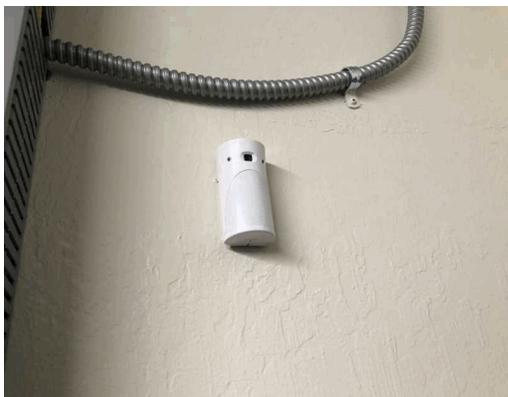
Item #: 794215
Uniformat Number: D7010
Item Title: Access Control and Intrusion Detection
Caption: Motion detector
Priority: 4 - Recommended

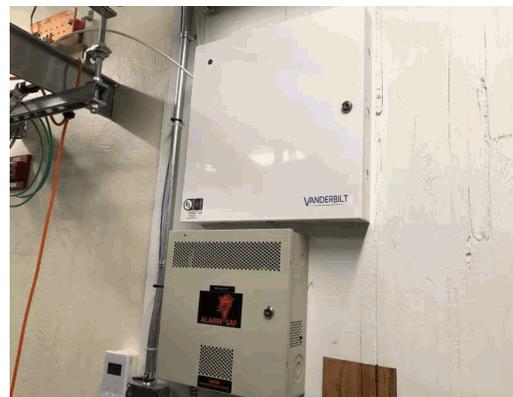
Item #: 794215
Uniformat Number: D7010
Item Title: Access Control and Intrusion Detection
Caption: Security panel
Priority: 4 - Recommended

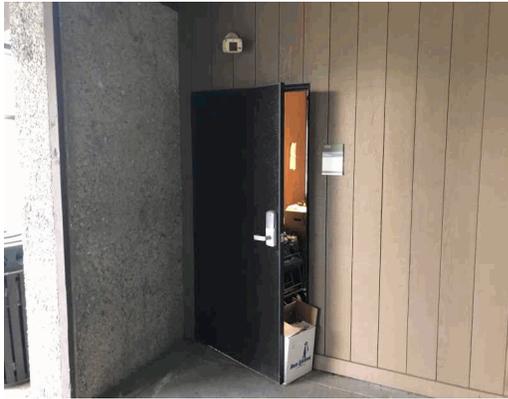
Item #: 794219
Uniformat Number: D7030
Item Title: Electronic Surveillance
Caption: Security camera
Priority: 4 - Recommended

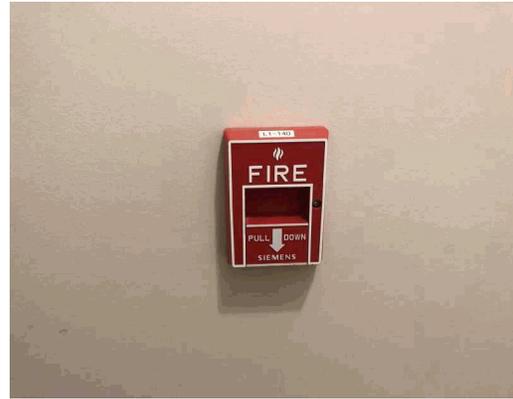
Item #: 794217
Uniformat Number: D7050
Item Title: Fire Detection and Alarm
Caption: Pull station
Priority: 4 - Recommended

Item ID	Uniformat	Description	Critical Issues	Recommendation	Pri	Act Time	Life Cycle	Estimated Cost
794217	D7050 Fire Detection and Alarm	Fire detection and alarm consist of the main fire alarm panel located in Building 6000, horn/strobes, heat/smoke detectors, extender panels, and wiring.	No deficiencies or negative impact issues observed however, as technology advances and equipment ages, upgrades to the systems will be required.	Continue to perform the manufacturer's recommended testing. Upgrade and/or replace the system components as necessary to ensure early detection of a fire and to allow maximum evacuation time and limited damage.	4	8	10	\$35,276
793665	E2010 Fixed Furnishings	Interior fixed furnishings consist of plastic laminate countertops, plastic laminate base cabinetry, and plastic laminate wall cabinetry.	Damaged plastic laminate finishes were observed.	Replace deteriorated cabinets and countertop system within the prescribed action timeframe.	4	7	15	\$45,859
