FACILITY CONDITION ASSESSMENT

FOOTHILL-DE ANZA COMMUNITY COLLEGE DISTRICT
FHDA Facility Condition Assessment
FOOTHILL COLLEGE
1900 ADMINISTRATION

Report for Project Planning

September 27, 2021

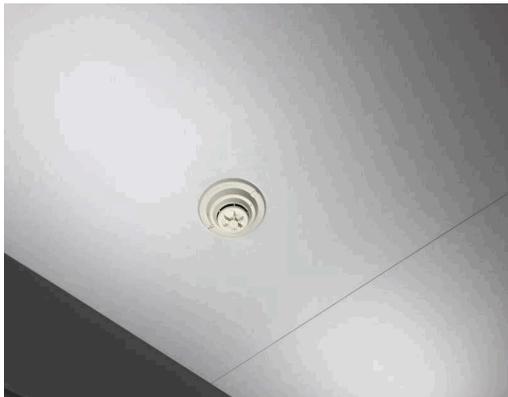
Item #: 794217
Uniformat Number: D7050
Item Title: Fire Detection and Alarm
Caption: Smoke detector
Priority: 4 - Recommended

Item ID	Uniformat	Description	Critical Issues	Recommendation	Pri	Act Time	Life Cycle	Estimated Cost
794217	D7050 Fire Detection and Alarm	Fire detection and alarm consist of the main fire alarm panel located in Building 6000, horn/strobes, heat/smoke detectors, extender panels, and wiring.	No deficiencies or negative impact issues observed however, as technology advances and equipment ages, upgrades to the systems will be required.	Continue to perform the manufacturer's recommended testing. Upgrade and/or replace the system components as necessary to ensure early detection of a fire and to allow maximum evacuation time and limited damage.	4	8	10	\$35,276
793665	E2010 Fixed Furnishings	Interior fixed furnishings consist of plastic laminate countertops, plastic laminate base cabinetry, and plastic laminate wall cabinetry.	Damaged plastic laminate finishes were observed.	Replace deteriorated cabinets and countertop system within the prescribed action timeframe.	4	7	15	\$45,859

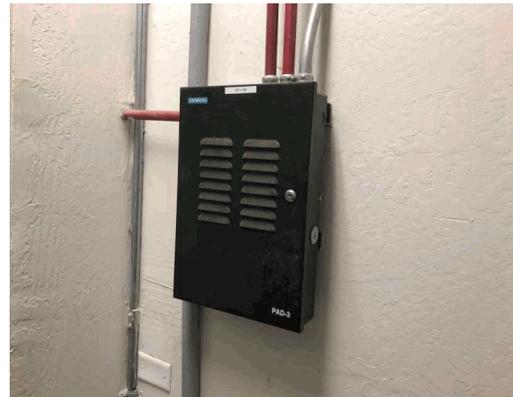
Item #: 794217
Uniformat Number: D7050
Item Title: Fire Detection and Alarm
Caption: Extender panel
Priority: 4 - Recommended

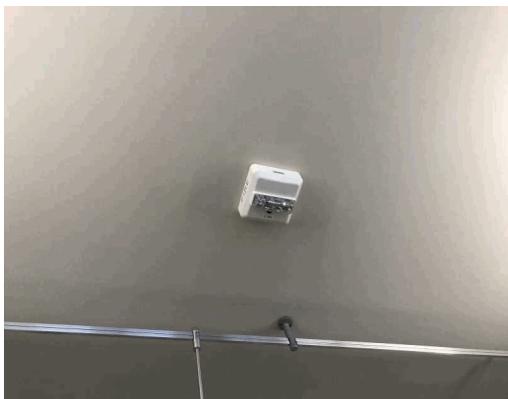
Item #: 794217
Uniformat Number: D7050
Item Title: Fire Detection and Alarm
Caption: Strobe light
Priority: 4 - Recommended

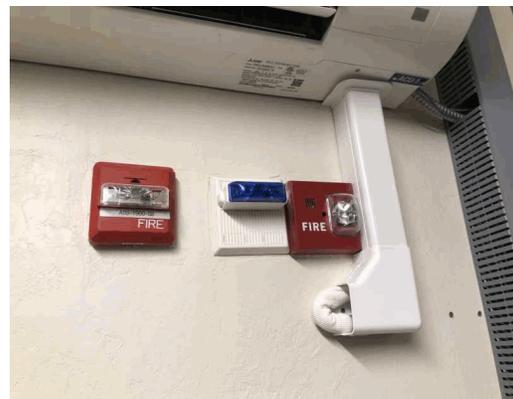
Item #: 794217
Uniformat Number: D7050
Item Title: Fire Detection and Alarm
Caption: Horn/strobes
Priority: 4 - Recommended

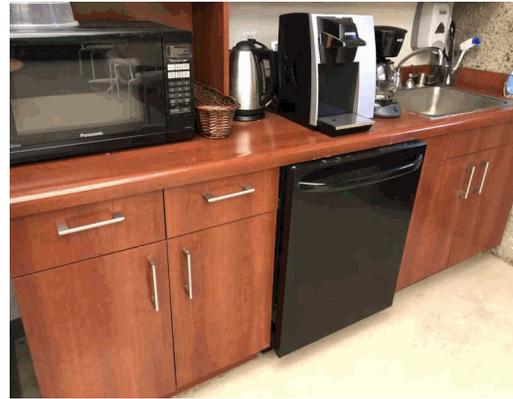
Item #: 793665
Uniformat Number: E2010
Item Title: Fixed Furnishings
Caption: Fixed Furnishings - Breakroom
Priority: 4 - Recommended

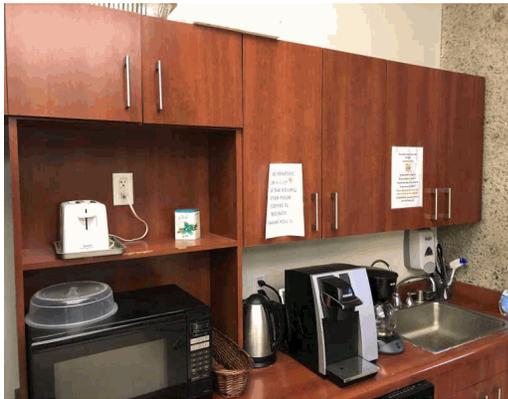
Item #: 793665
Uniformat Number: E2010
Item Title: Fixed Furnishings
Caption: Fixed Furnishings - Breakroom
Priority: 4 - Recommended
